COMPLETION PRODUCTS

TUBING/CASING PATCHES

Halliburton's tubing/casing patches provide a heavy-duty permanent seal over splits, holes, or perforations in tubing and casing. The patches are run on electric wireline or tubing and set with a special pressure-setting tool that has a special charge similar to that used to set a permanent packer. These patches feature large bores to allow passage of tools and equipment and minimize restriction to fluid flow.

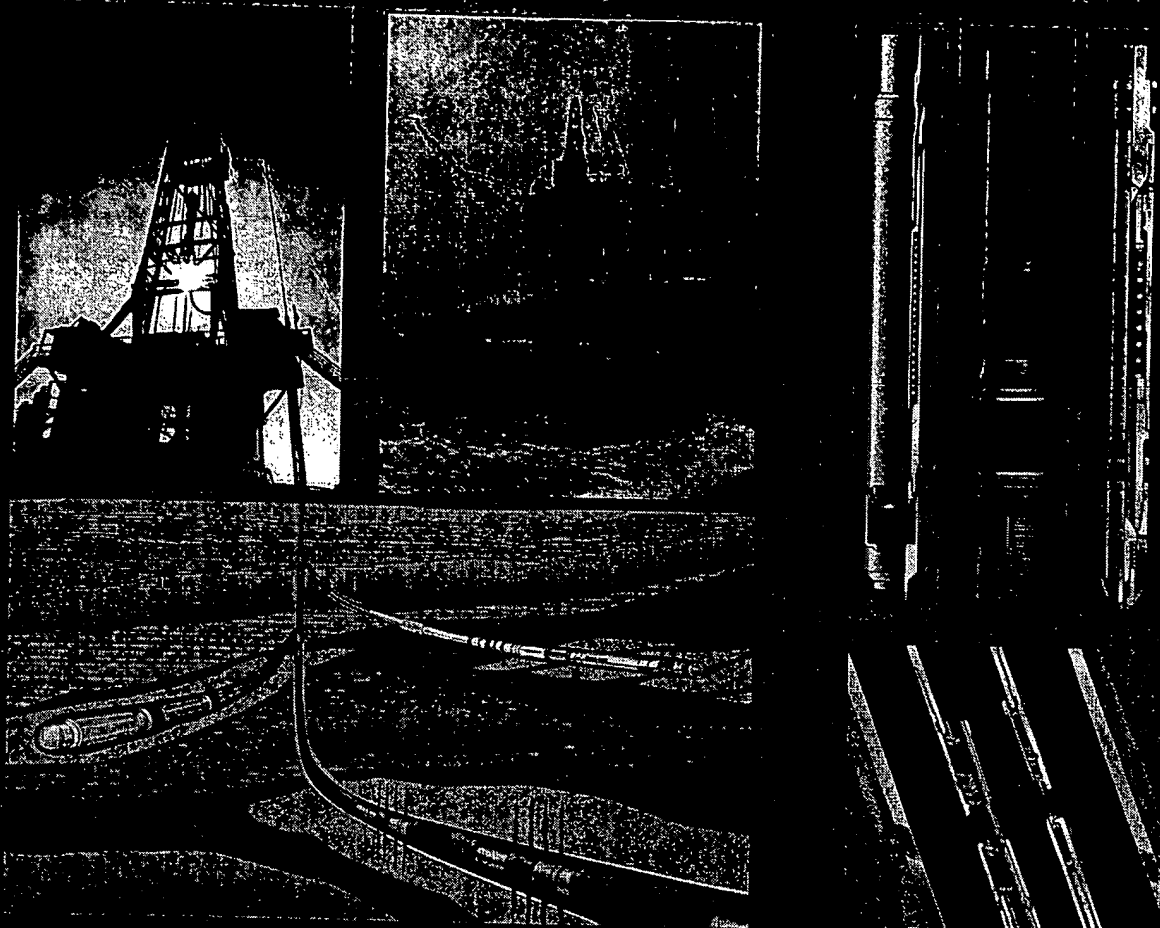
Tubing/casing patches have three components:

- Top soft metal element with a rubber seal
- Tubular extension with threaded ends
- Bottom soft metal element with a rubber seal

Various patch lengths and bottom elements are swaged outward during the setting process. The tubular extension is not swaged. During setting, the pressure setting tool exerts a pushing force on the top tapered swage and a pulling force on the bottom tapered swage. Both swages are driven into the soft metal elements that expand and seal against the casing bore. At a predetermined force, a calibrated weak point shears in the setting tool, and the setting process ceases. A collapsible setting collet located in the bottom swage retracts and allows the pressure-setting tool and setting equipment to be retrieved. The damage interval is now isolated by a full circle metal-to-metal and rubber seal.
